Full-field Deformation Measurement Techniques for a Rotating Composite Shaft

Lee W. Kohlman¹, Charles R. Ruggeri¹,
Richard E. Martin², Gary D. Roberts¹,
Robert F. Handschuh¹

¹NASA Glenn Research Center

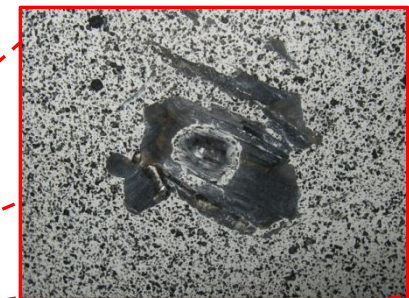
Image of Damage

Two low speed impacts were performed using a 1/4" steel ball bearing to induce delamination in the composite tube.

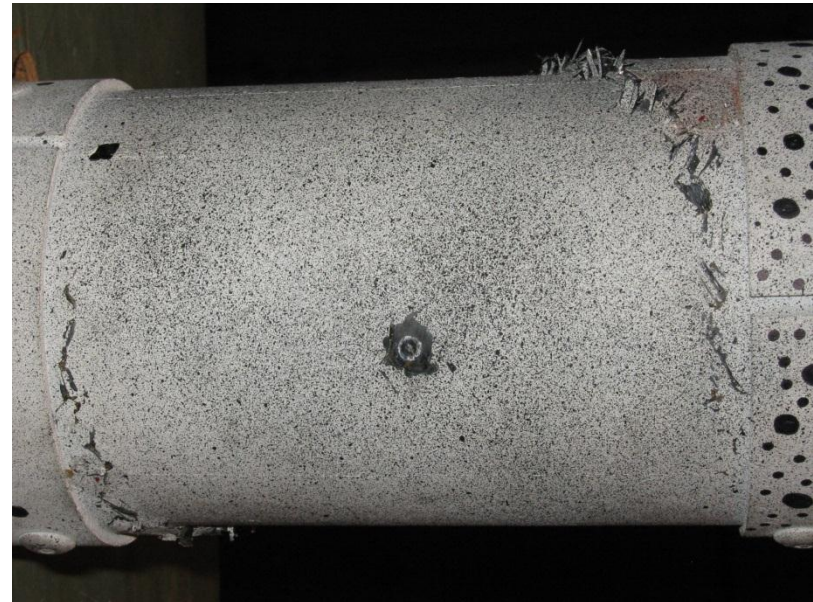
Failure Image

The tube failure initiated at the impact damage location on the back of the tube.

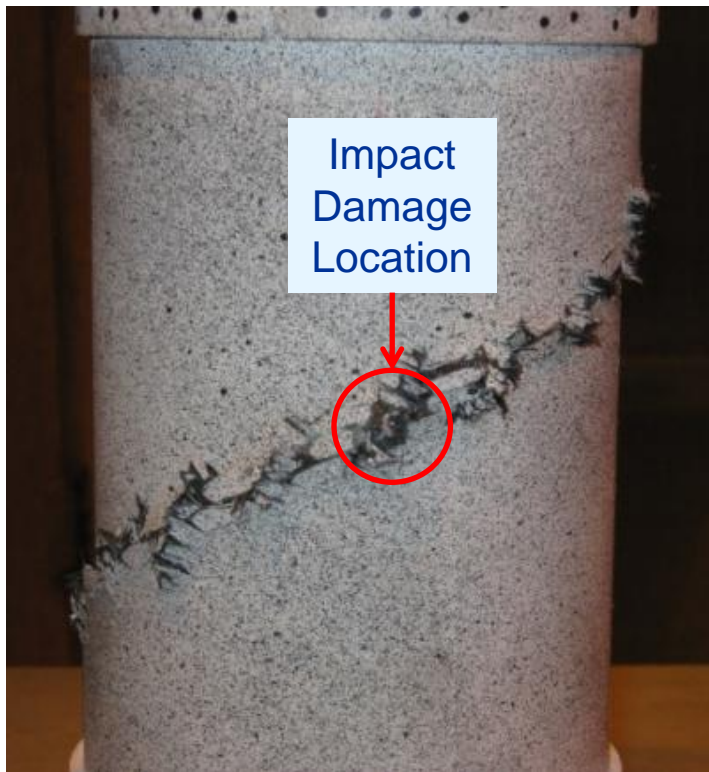
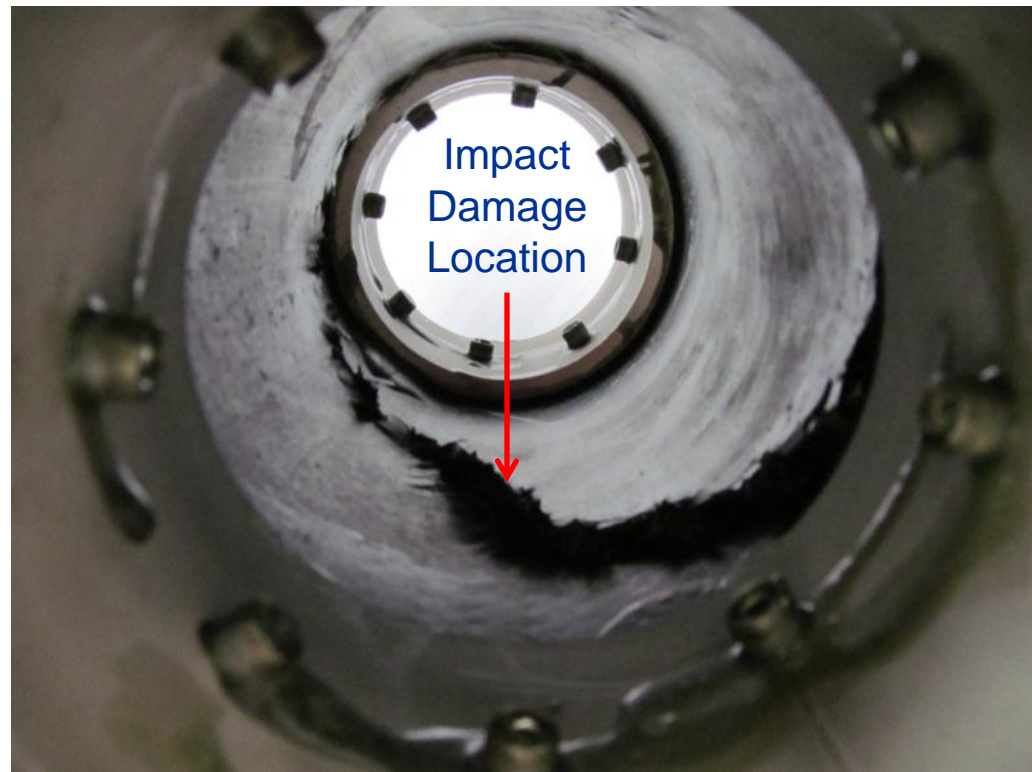
Failed Tube

- Local buckling and delamination resulted in shear failure of the composite tube

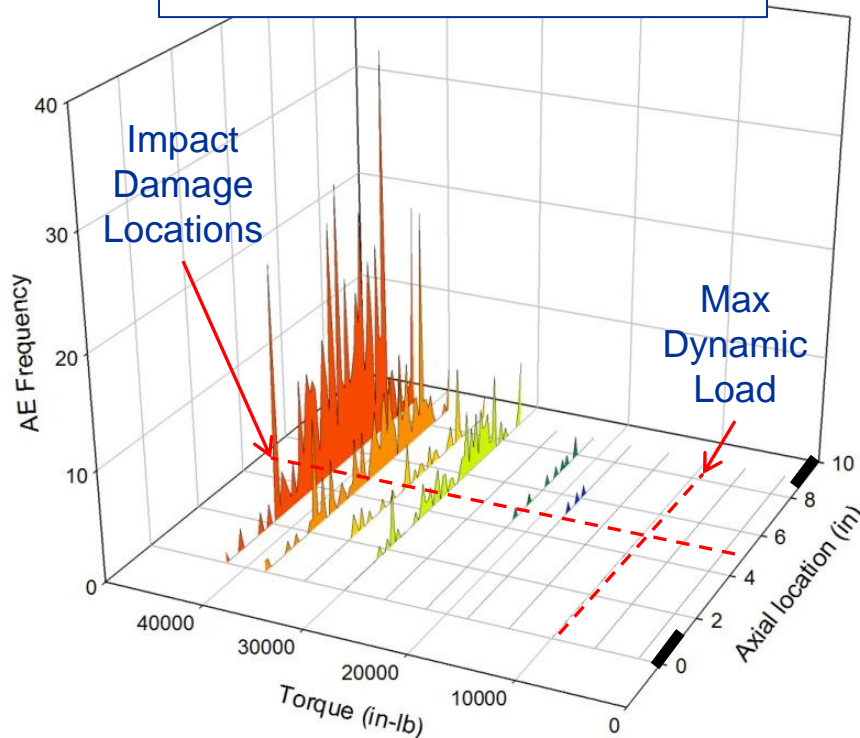
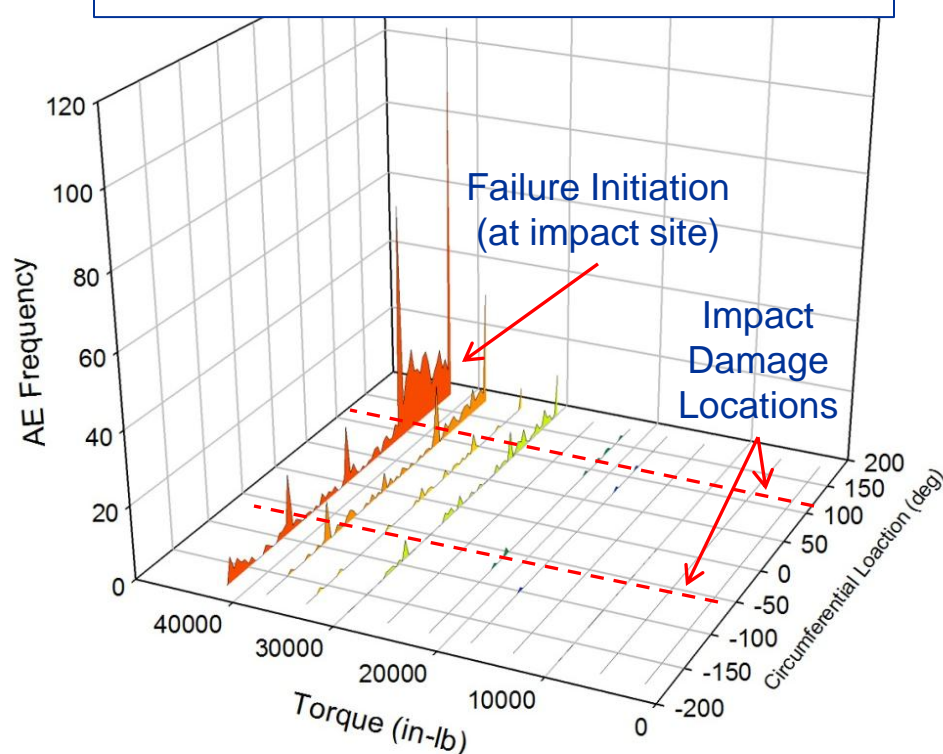
- Acoustic emission agrees with the development of additional damage at the impact damage locations
- Near higher loading, damage also occurs in attachment region

Axial Location of AE Events

Circumferential Location of AE Events

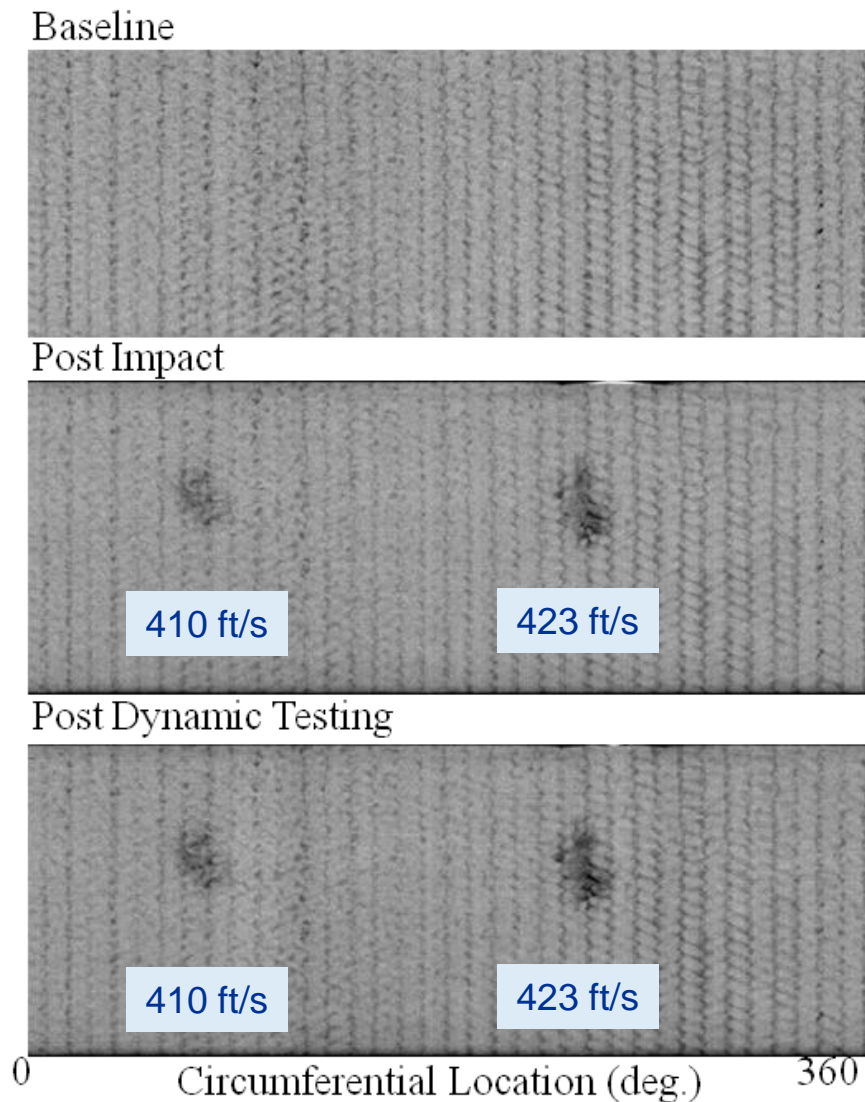
X-ray CT Observation of Damage

- No damage growth was observed following the dynamic test of the damaged tube
- Failure of the tube in the static test corresponded to the more severe damage observed by X-ray CT and higher impact velocity
